## MAHANoy TOWNSHIP DAM NO. 2

NDS ID NO. PA-885

PHASE I INSPECTION REPORT  
NATIONAL DAM INSPECTION PROGRAM

L. ROBERT KIMBALL & ASSOCIATES  
CONSULTING ENGINEERS & ARCHITECTS  
EBENSBURG, PENNSYLVANIA  
15931

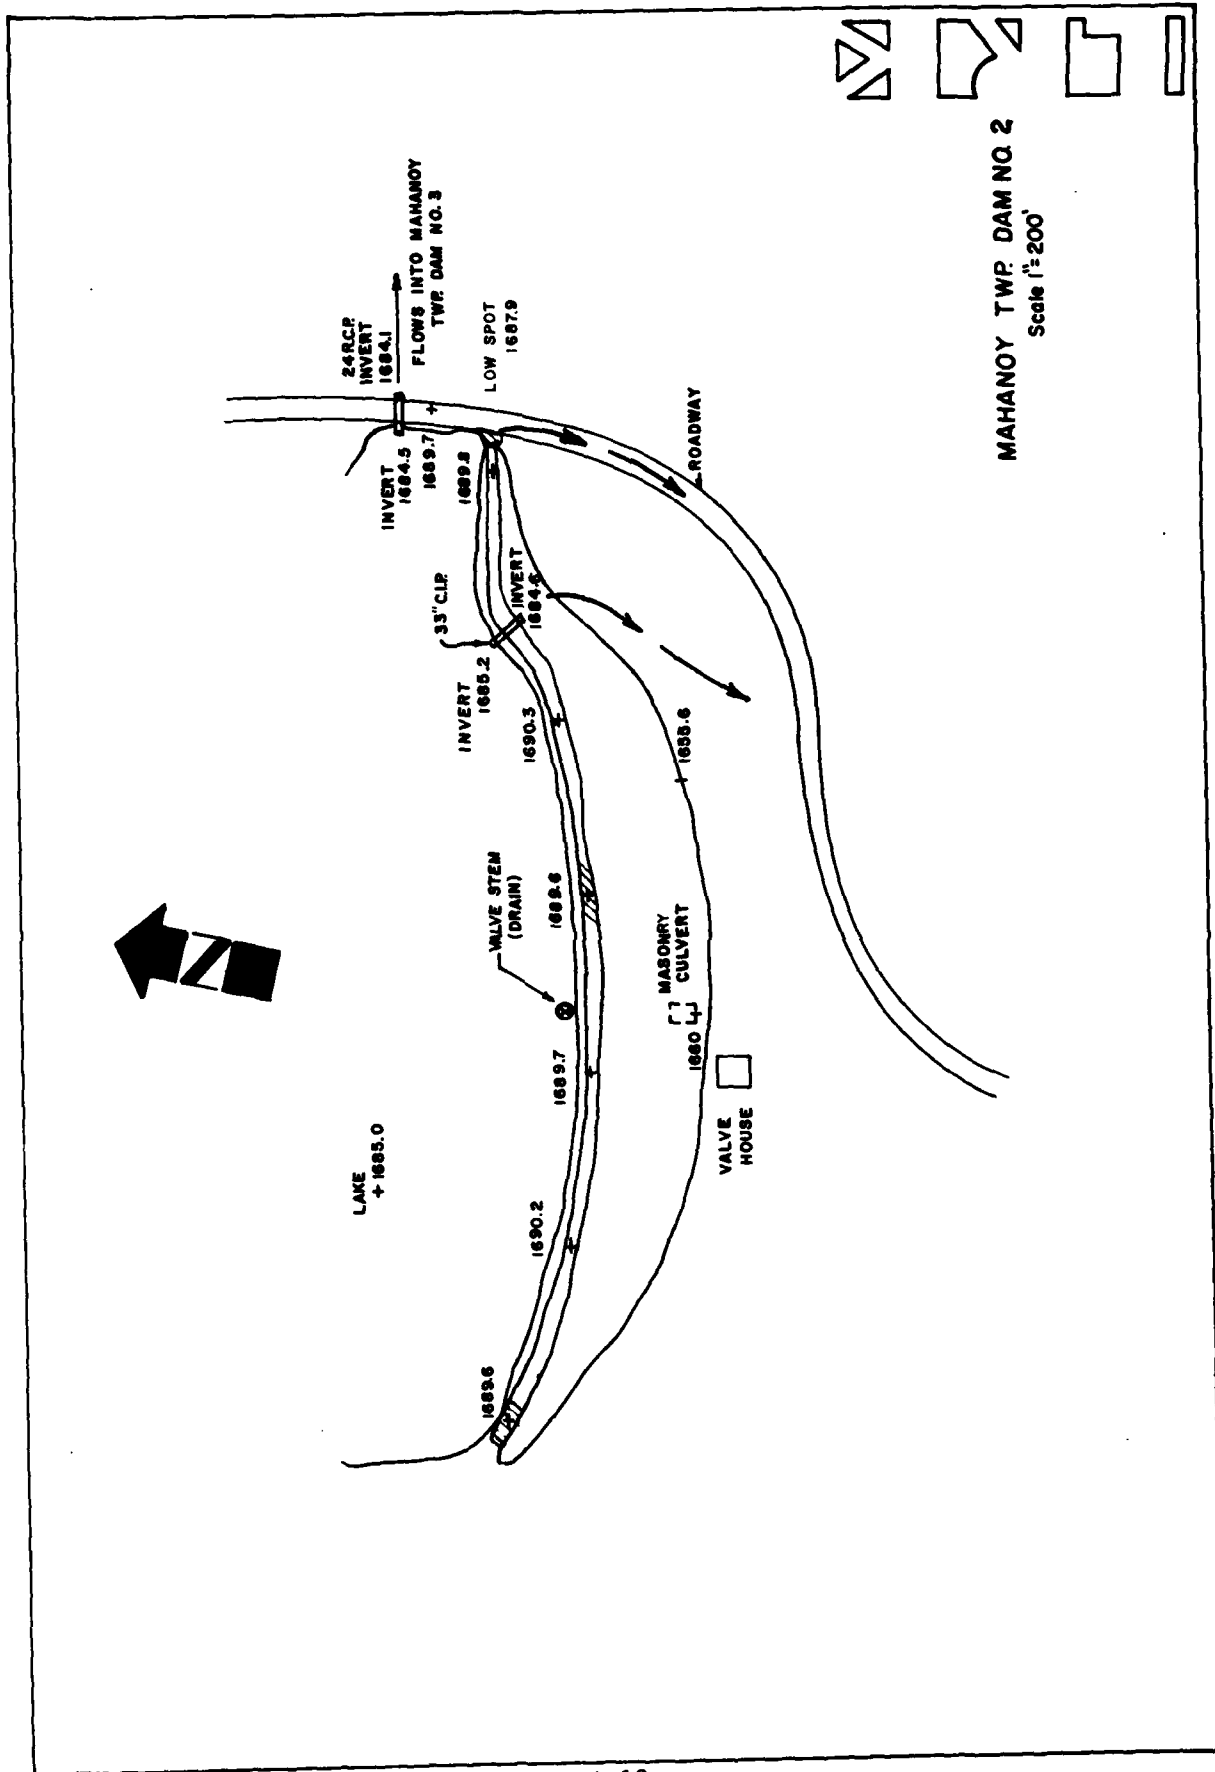
PROFILE  
LOOKING UPSTREAM

b. Dam. The dam appears to be in fair condition. From a brief survey conducted during the inspection, it was noted that the crest of the dam rises toward the right abutment. The low spots on the main embankment occur at approximately Station 6+00 and at the right abutment. A second low spot was noted at the left abutment and could provide additional spillway capacity since the area is in natural ground. The upstream slope was measured to be 2H:1V and covered with riprap. The crest width was measured to be 15 feet. The downstream slope was grass covered and was measured to be 1.5H:1V. No seepage or erosion areas were noted during the inspection.

A low spot was noted on the main embankment at approximately Station 6+00. This area is distinguished from the low spot located near the left abutment since it occurs on the main embankment in an area susceptible to erosion due to overtopping, and critical in regards to embankment stability.
